# Manhole Inspection Summary

Manhole # S3100\_017MH

Insp Date: **4/25/07 12:16 PM**

**Location** Address: **424 FAWCET ST**

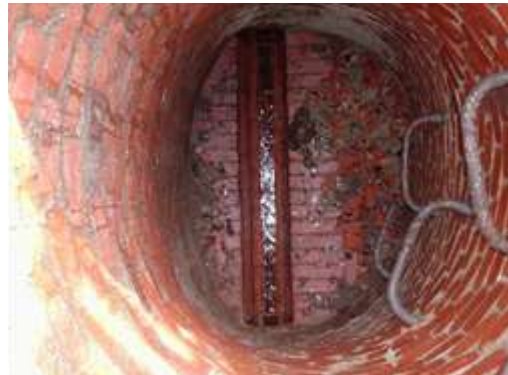
Top View

Corroded steps. Bench debris.

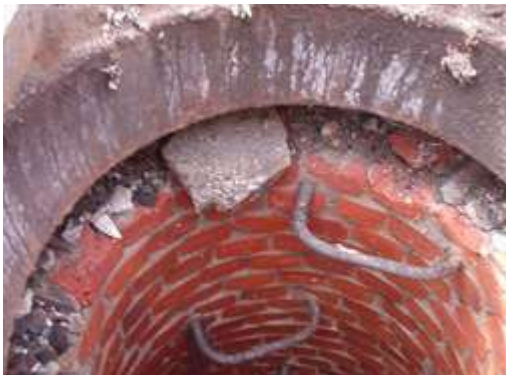
Defect

Frame leaks. Frame offset. Adjustment deterioration, loose brick and infiltration.

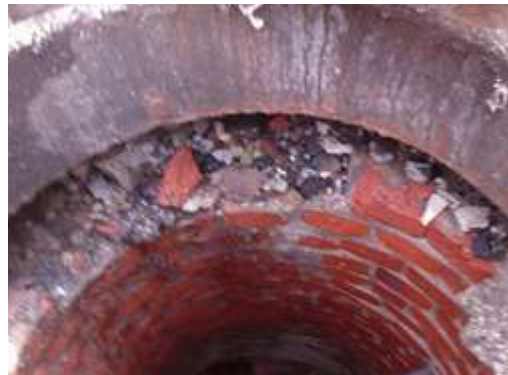
Defect

Frame leaks. Frame offset. Adjustment deterioration, loose brick and infiltration.
